## NAVAL AVIATION SAFETY CENTER

1. AIRCRAFT ACCIDENT BOARD APPOINTED BY	2. SERIAL NO	3. DTG (LOCAL) OF MISHAP	4. MODEL AIRCRAFT	5. BUREAU NUMBER
CO. VMO-5	1-57A	141245Z Apr 67	UH-1E	152437
6. TO Commander, Naval Aviation Safety Center	7. LOCATION OF MISHAP	8. TIME OF DAY	9. TIME IN FLIGHT	10. DAMAGE
VIA CO VMO-5	0680 RAD 10NM S1 Toro TACAN	NOON	0 + 26	ALPHA
CO MHTG-30	11. TYPE OF DAY	12. TIME IN FLIGHT	13. FLIGHT CODE	
CO 3dMAW	14. CLEARED FROM	15. TYPE CLEARANCE	16. AIRSPEED	17. A/C WEIGHT
CO ENRPAC	Coast Guard	VPR	60 kts E	7150
COMNAVSTA PAC	Station Pt. Vicente	18. ELEVATION AT TIME OF MISHAP	19. TERRAIN	(CRASH) 0
18. BRIEF DESCRIPTION OF MISHAP	20. LIST MODEL BUNO, REPORTING CUSTODIAN AND DAMAGE CLASSIFICATION OF ANY OTHER A/C INVOLVED	NONE		
Probable attempt at Forced Landing in Marginal Wx

VMO-5 AAR 1-67A, of 14 APRIL 1967, UH1E BUNO 152437, PILOT GREENLEESE  
"SPECIAL HANDLING REQUIRED IN ACCORDANCE WITH OPNAVINST 3750.6 SERIES"

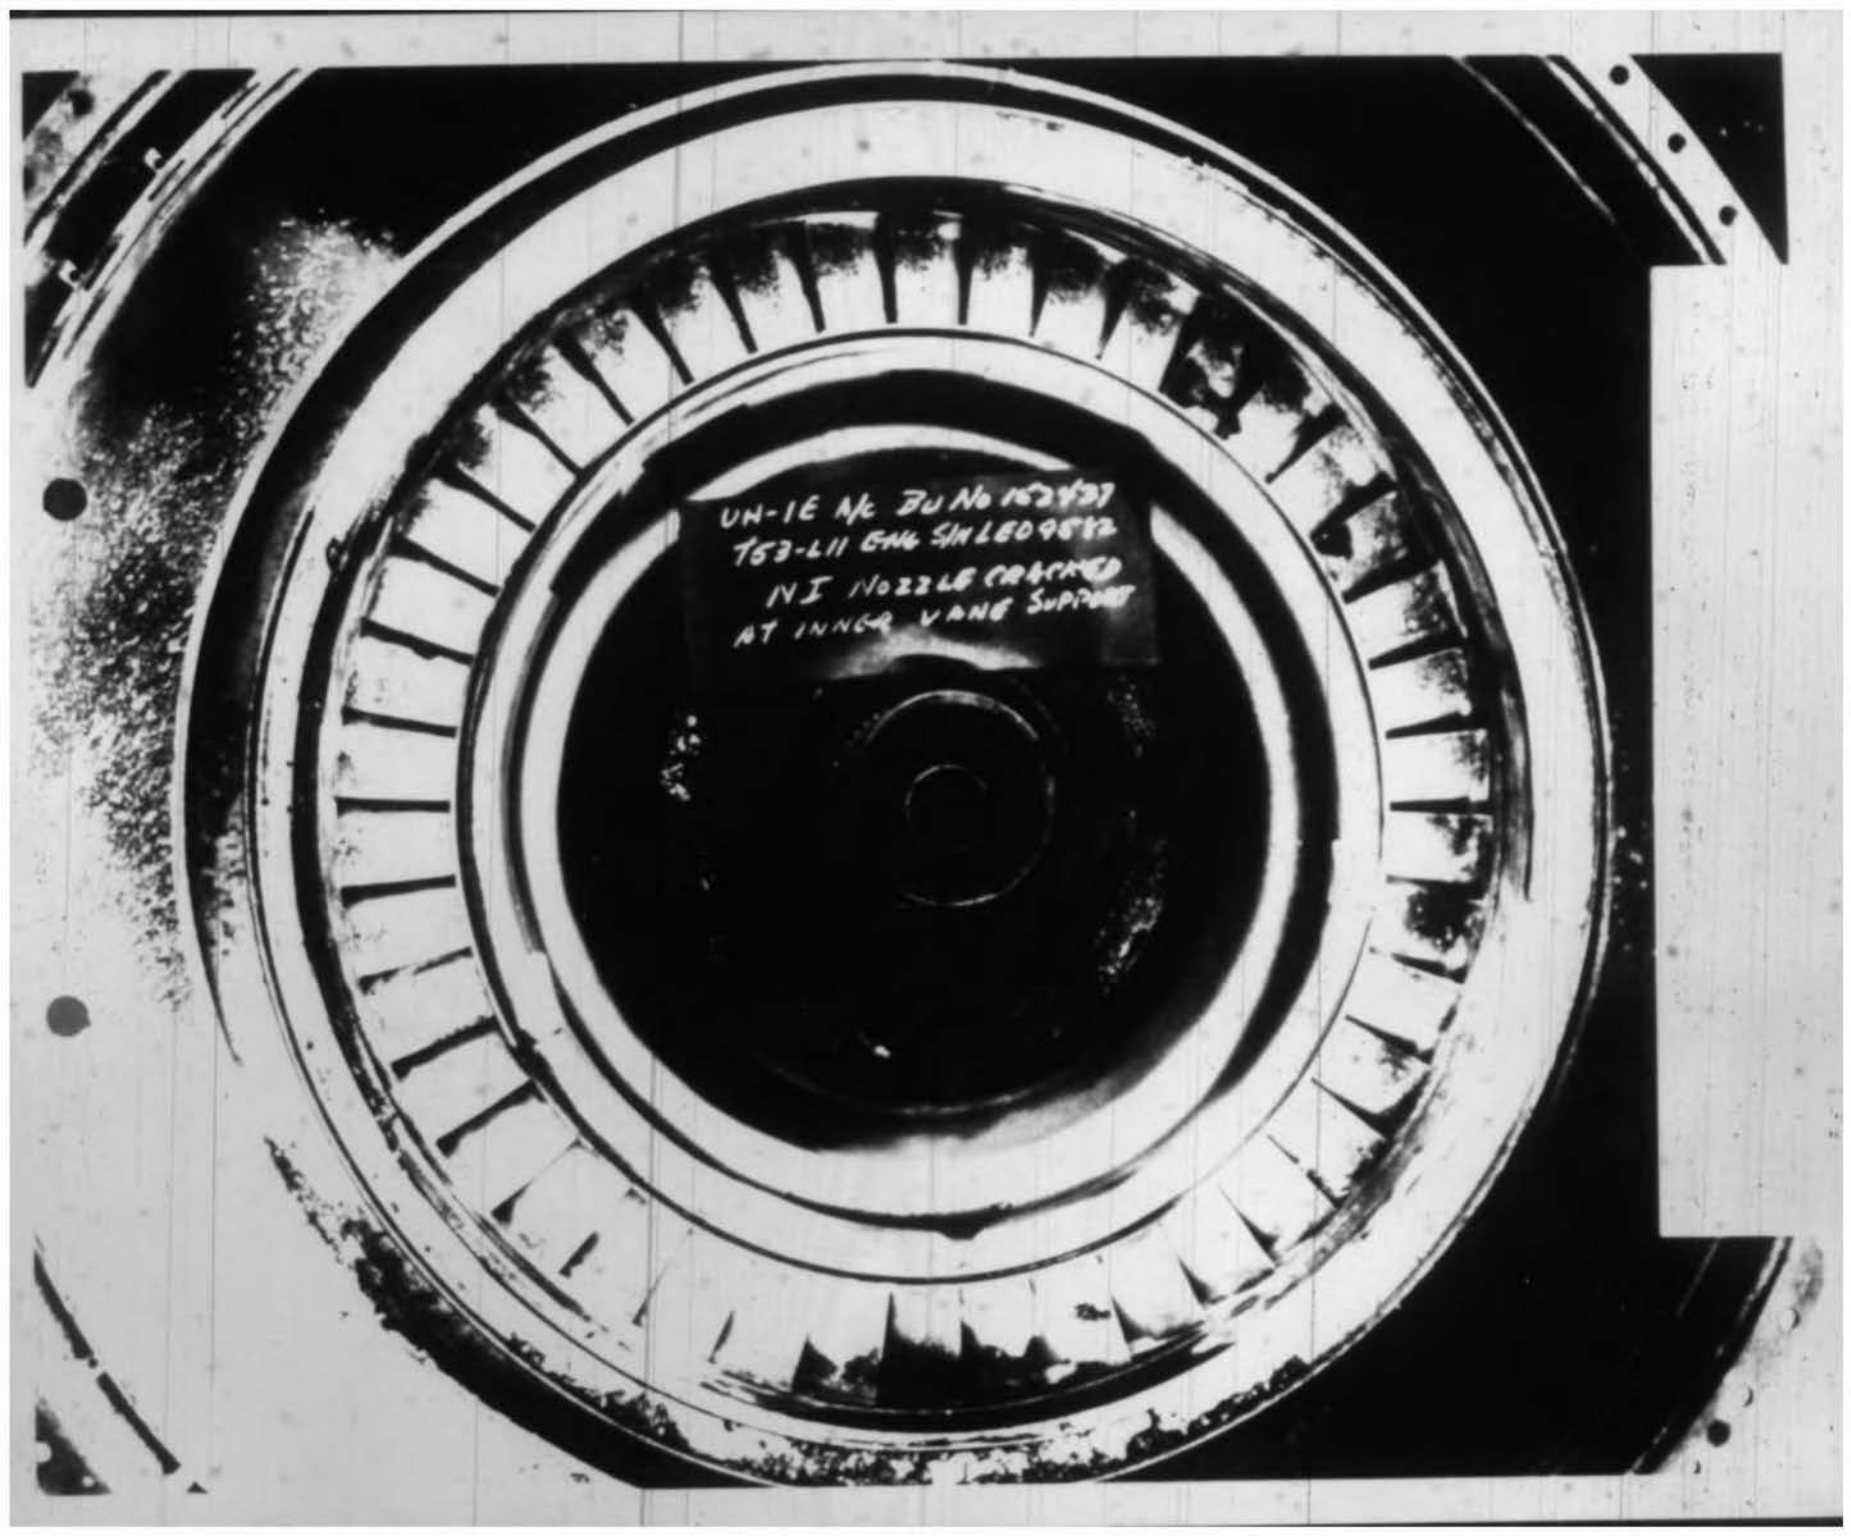
UN-1E AK Bu No 162437  
T53-L11 ENL SN 1609812  
IN I NOZZLE CRACKED  
AT INNER VANE SUPPORT

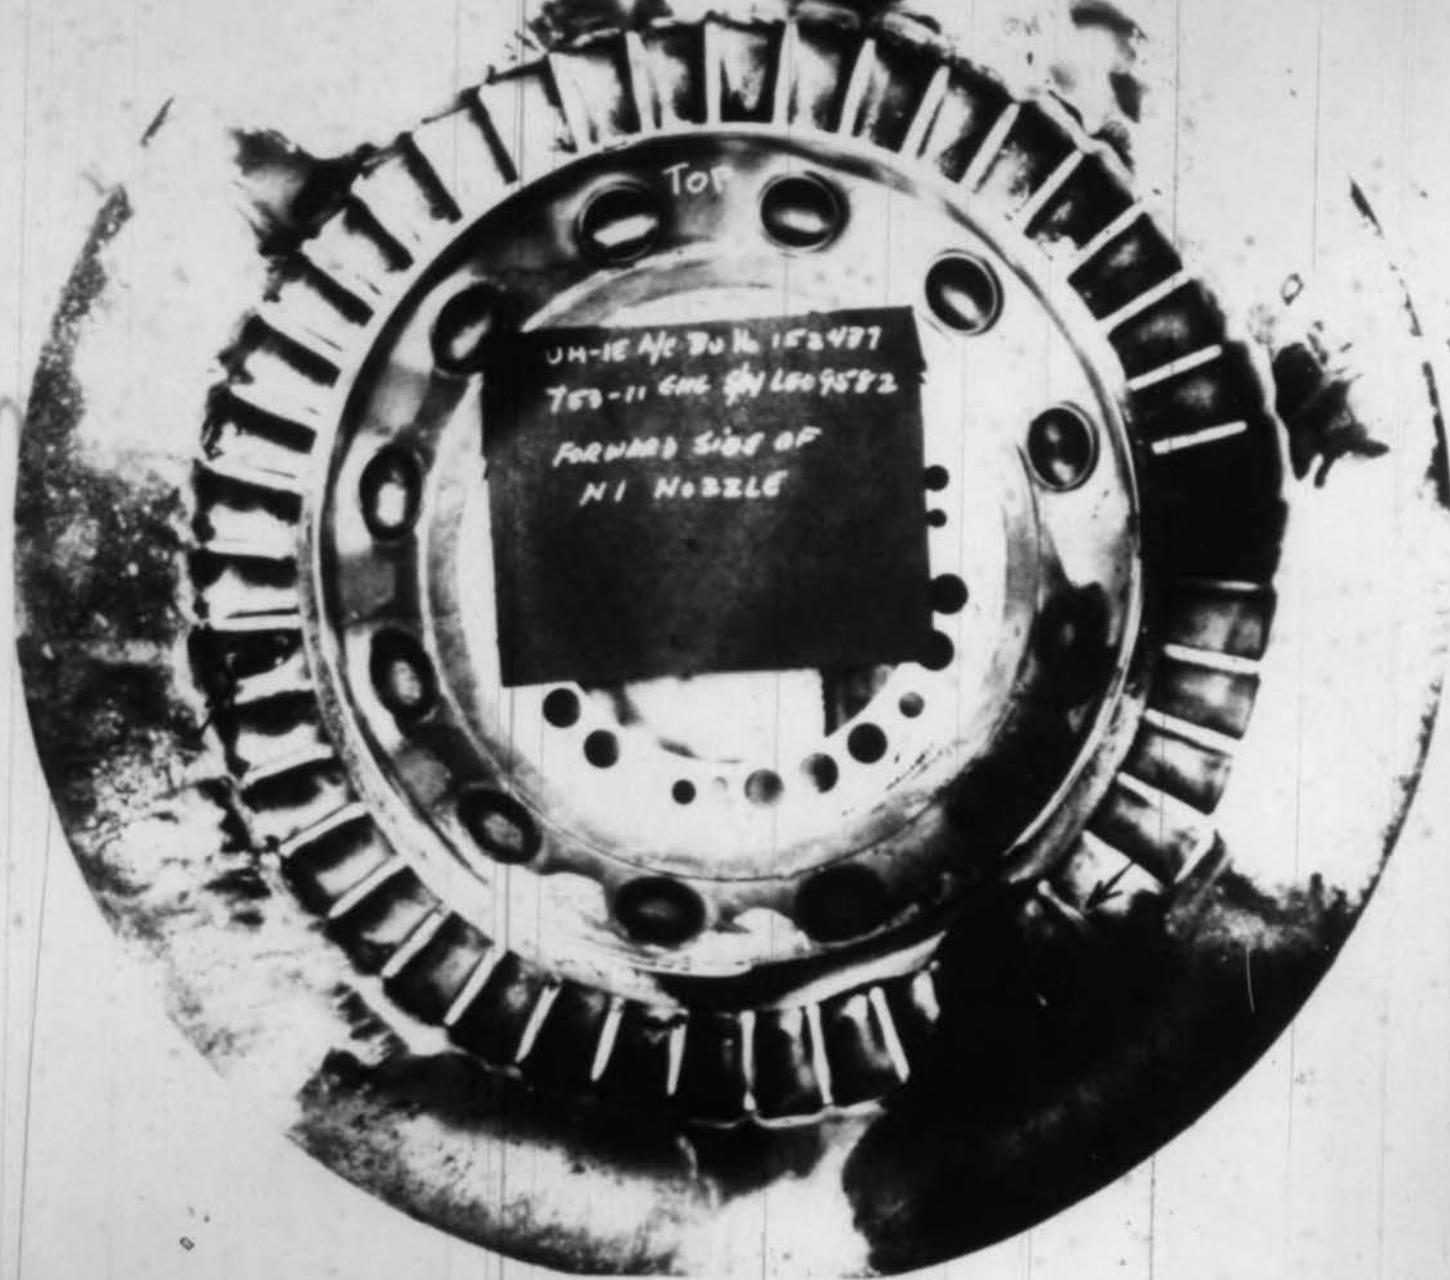
UH-1E A/C Bu No 152487  
T63-11 CMC S/N L609582  
FORWARD SIDE OF  
N1 NOZZLE

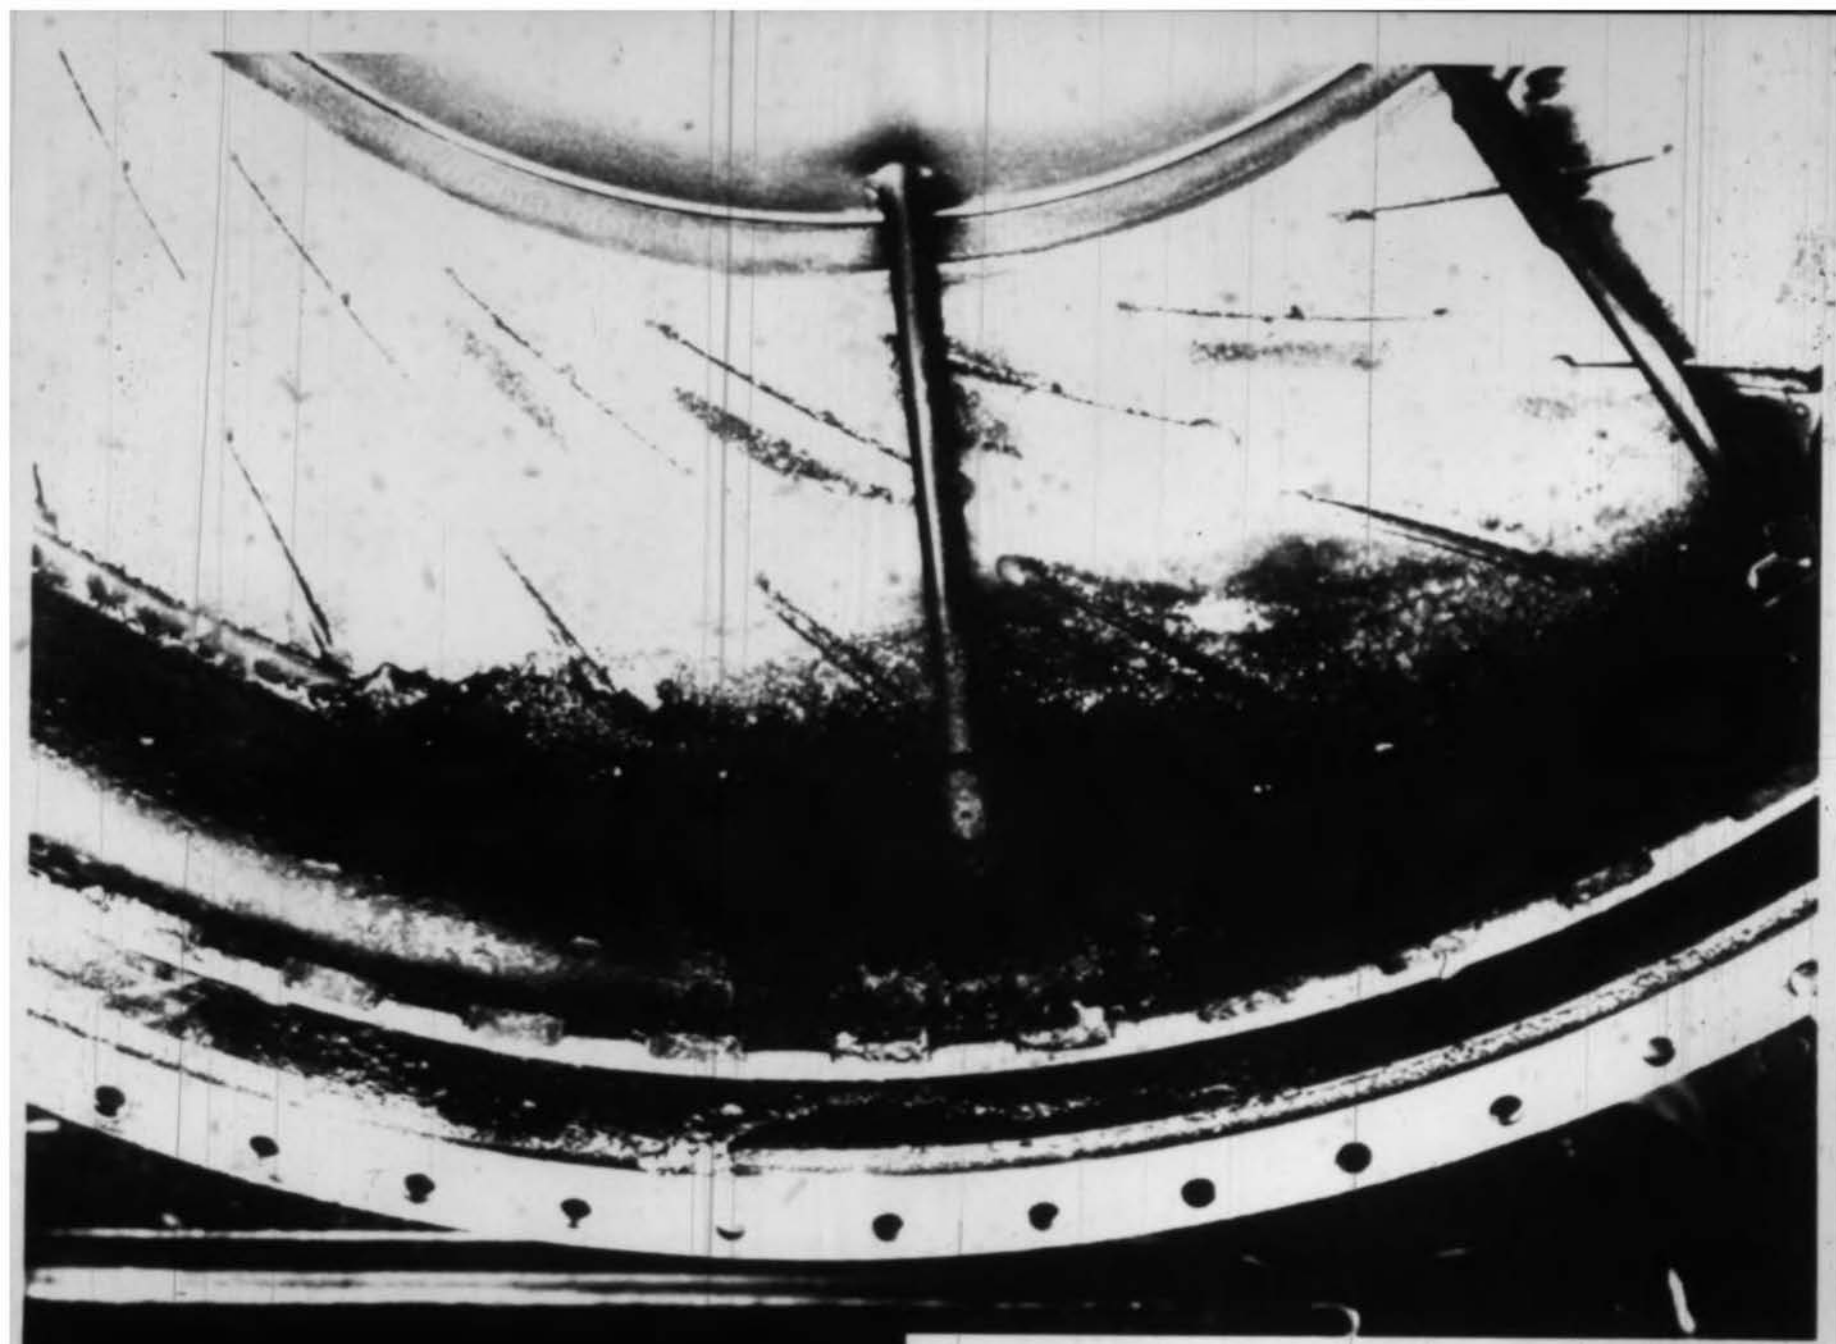
UH-1E A/C BuNo 152437  
T63-L11 ENG IN LEO9582  
COMPRESSOR SHAFT  
CONTACTED N2 TURBINE  
STUB SHAFT

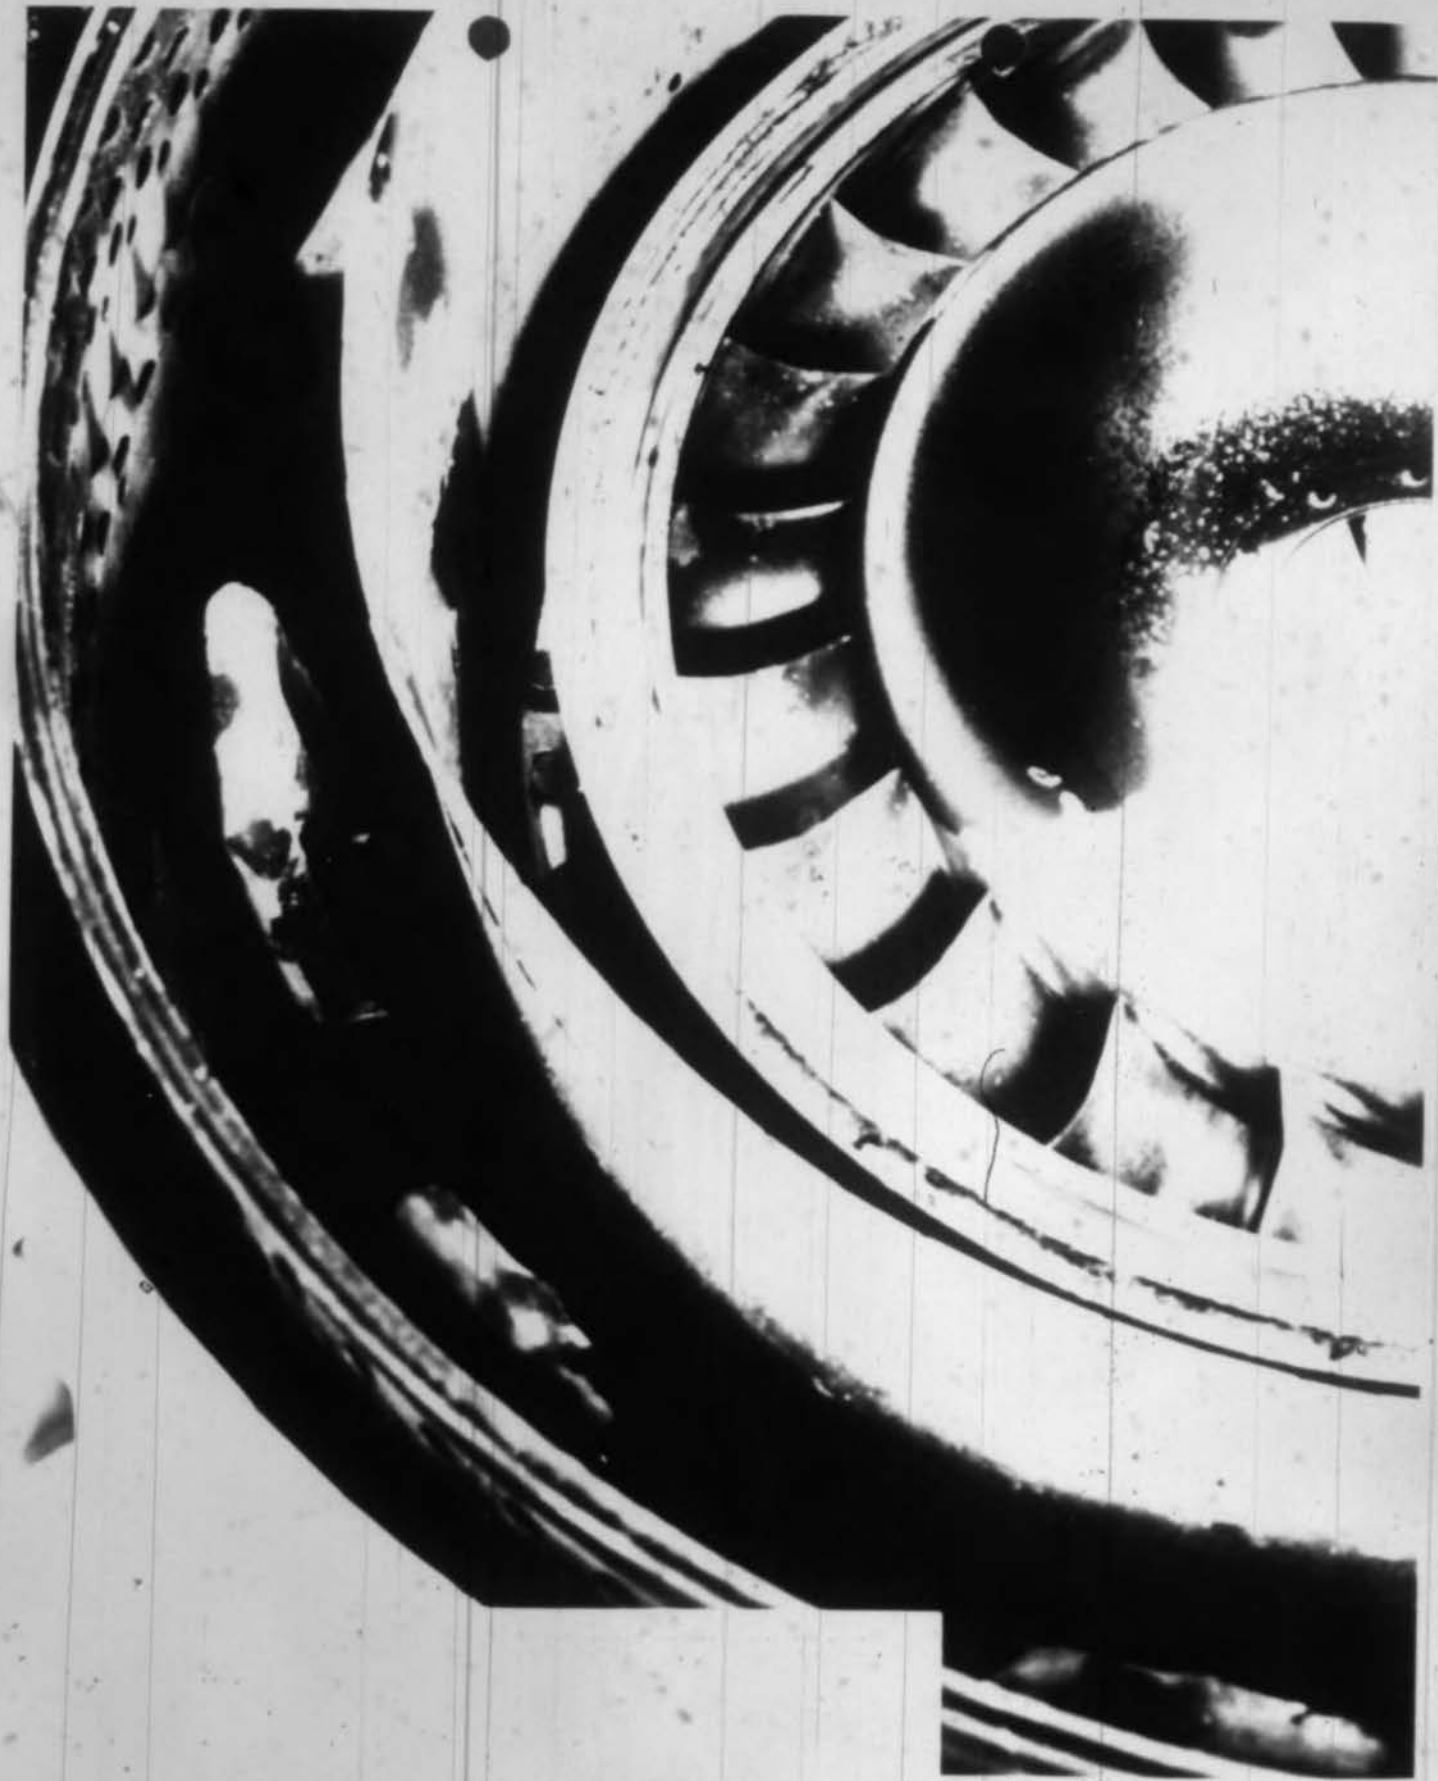
24-1E A/C Bu No 152437  
TED-LIN ENG SN 1609582  
NOTE TWO DEFINITE  
MARKINGS (1) HIGH SPEED  
MACHINING (2) STATIONARY  
IMPACT MARKING

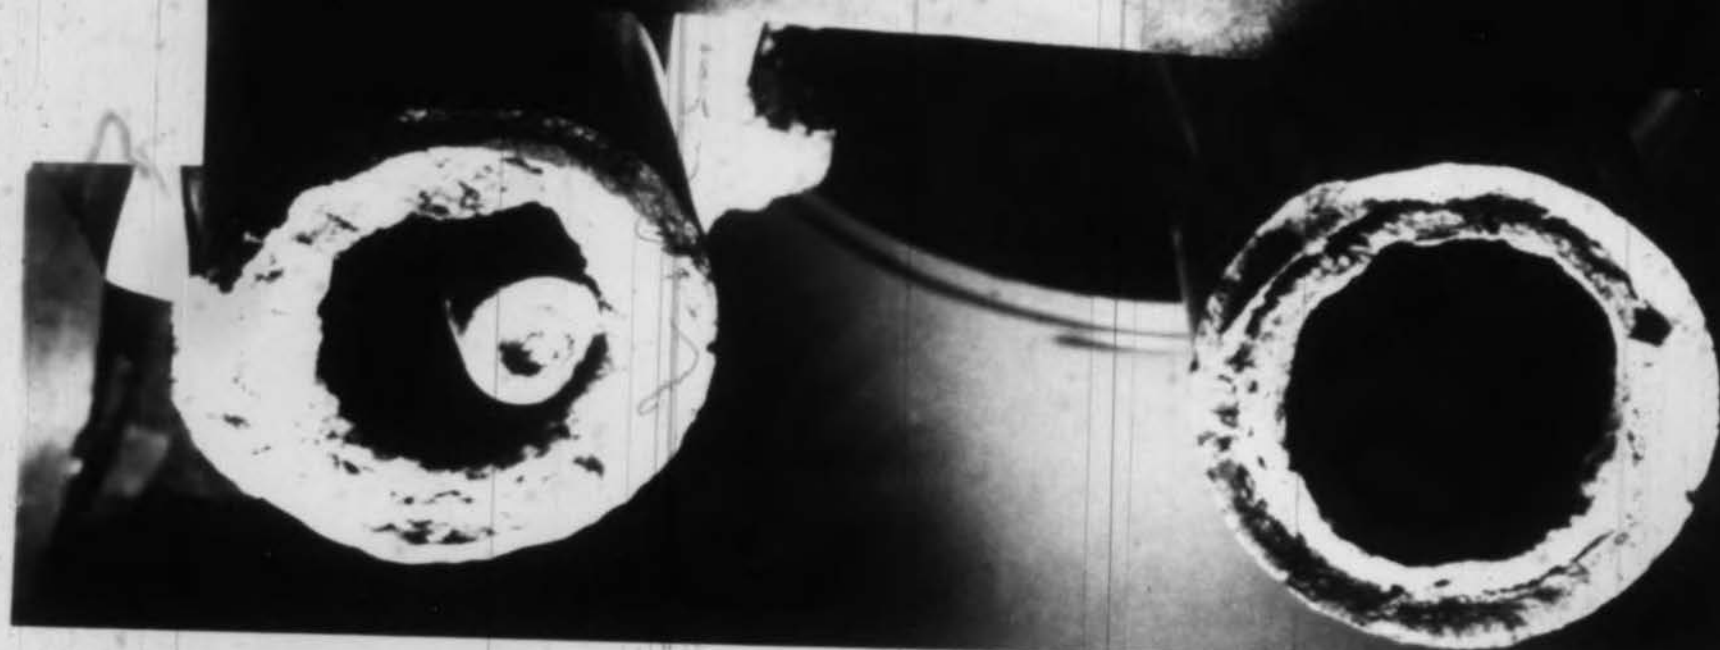
UH-1E A/C BU NO 152437  
FRACTURE ON  
RED BLADE  
STABILIZER BAR

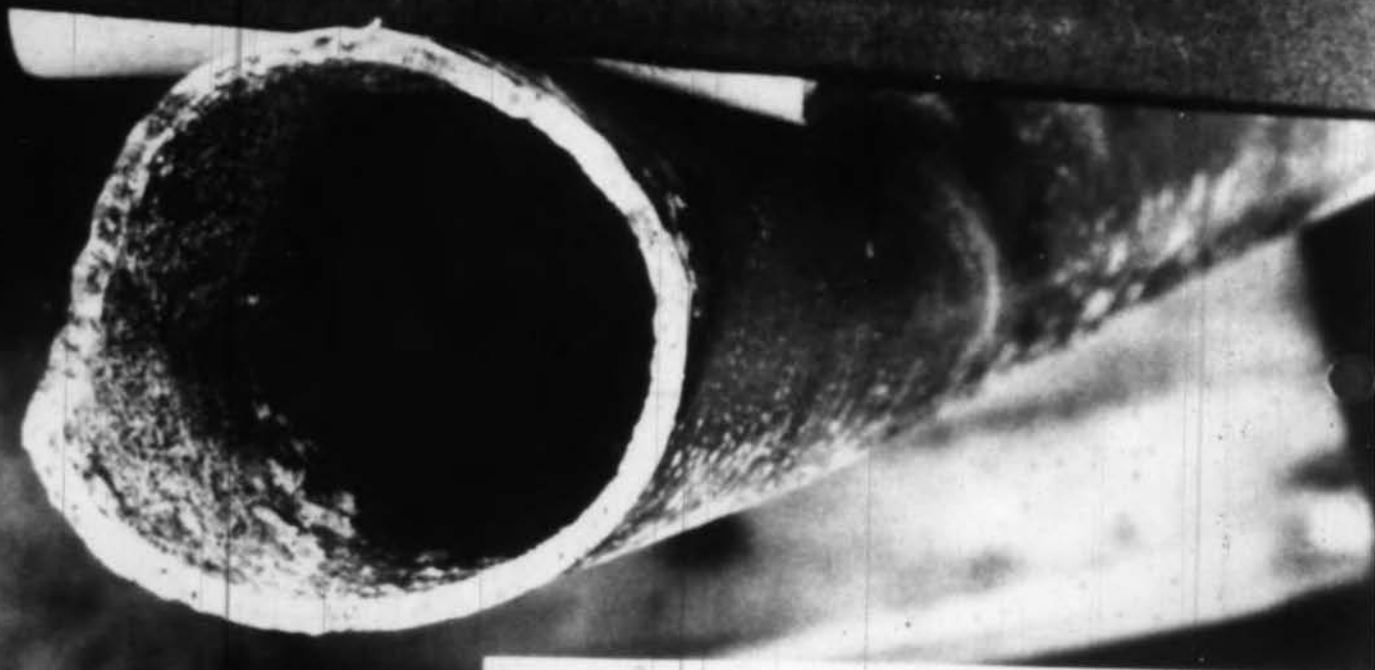
UH-1E A/c BU No 152437  
WHITE BLADE CONTROL  
TUBE FRACTURE

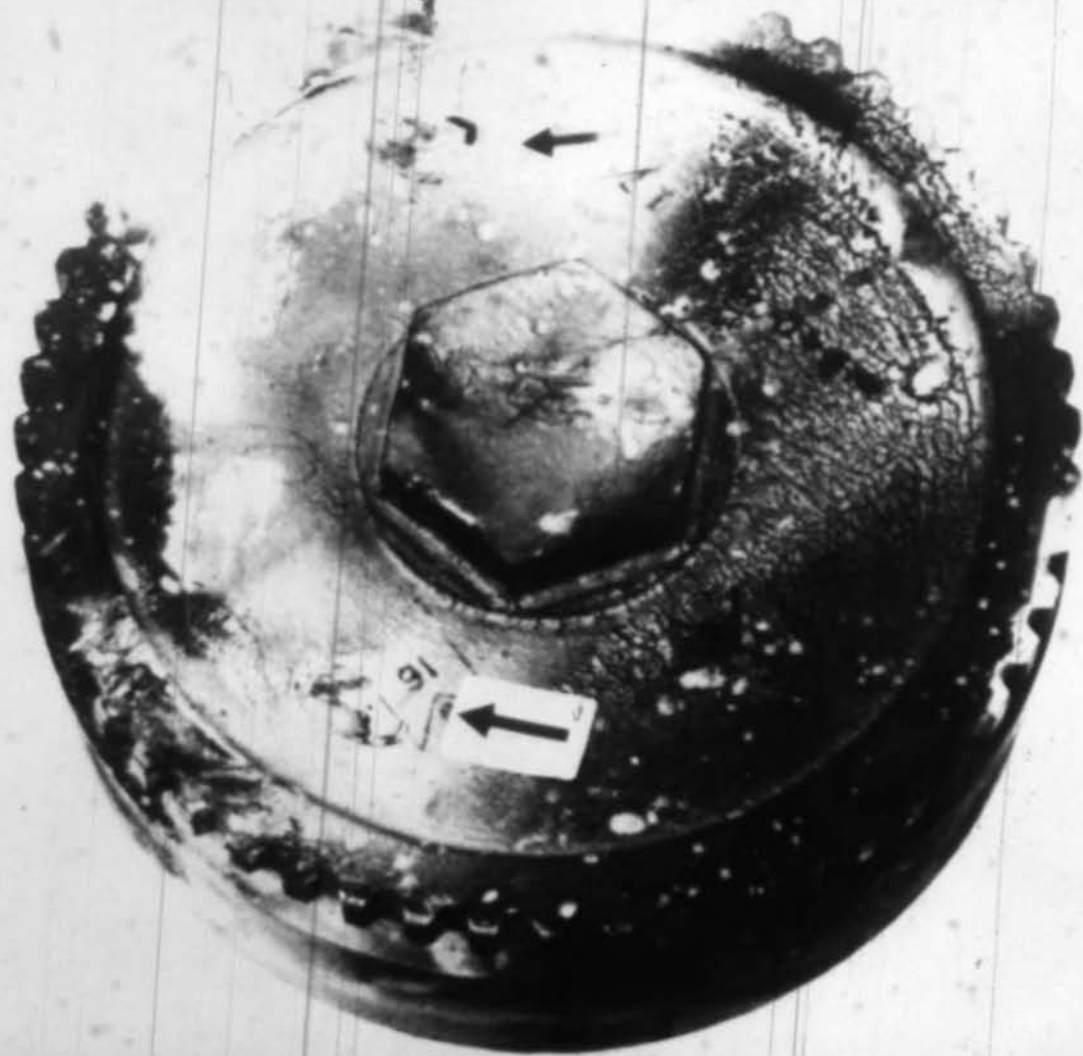
UH-1E A/C Bu No 152437  
GRID NUT ON WHITE  
BLADE HAD ONLY MINOR  
DAMAGE

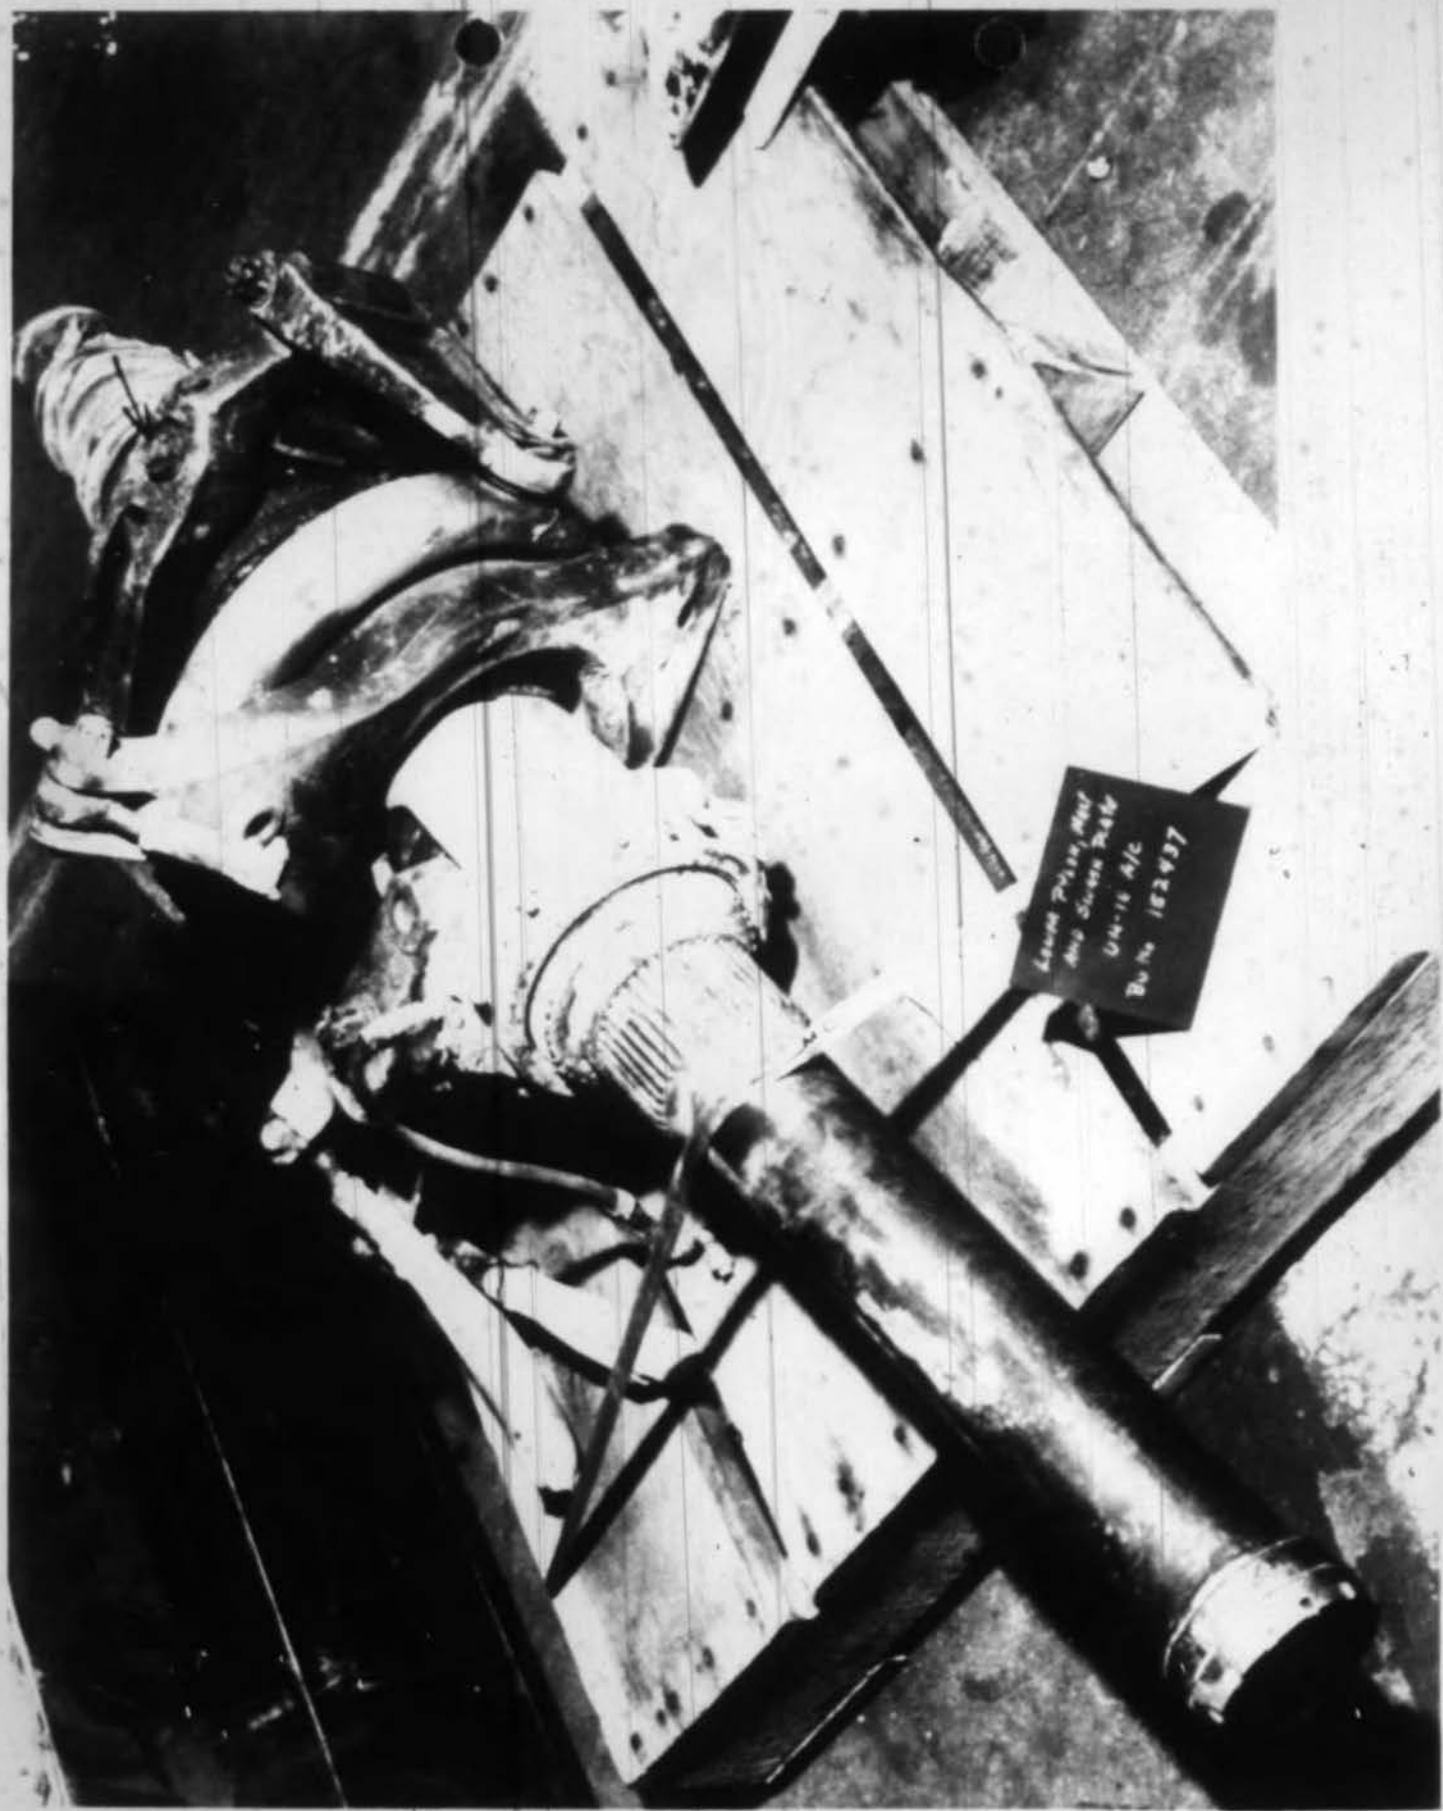
UN-1E A/C BU NO 152437  
AFT FITTING ON INNER  
RING FRACTURED ON  
SWASH PLATE AND SUPPORT  
1554.

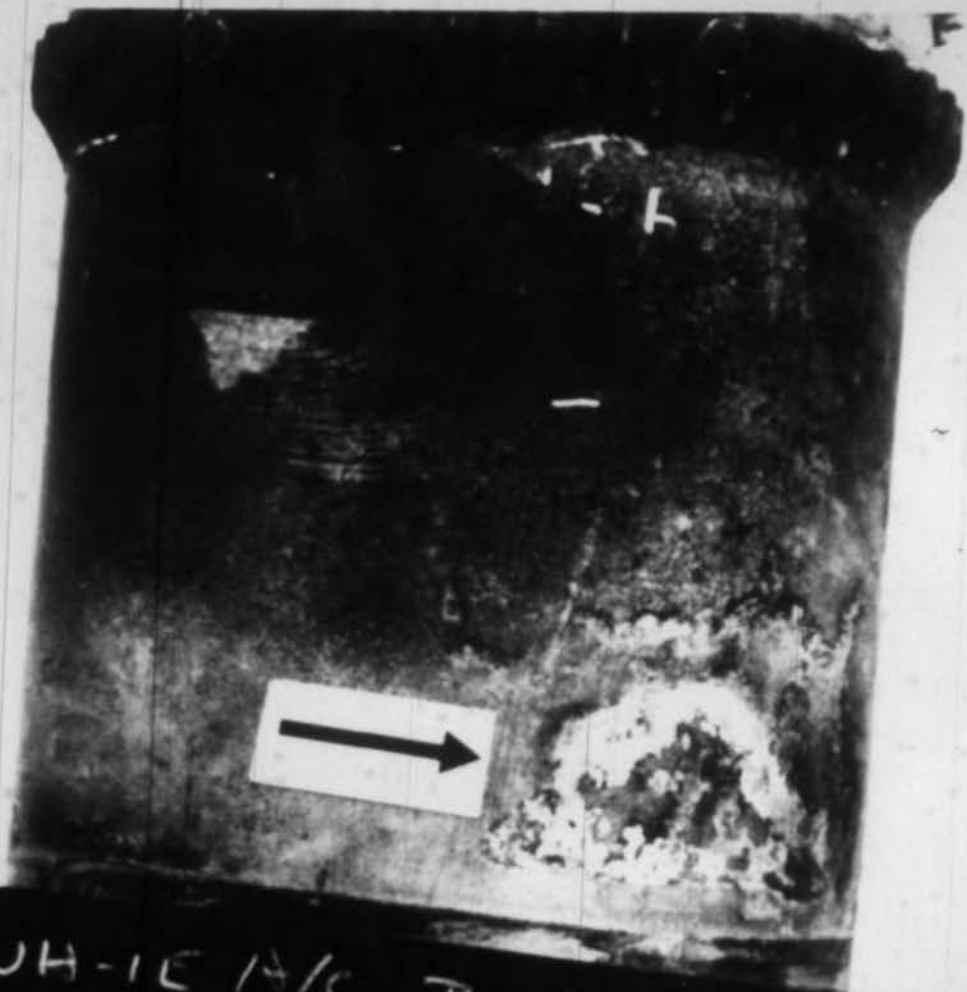
NOTE EXCESSIVE MAST  
BUMPING ON RED BLADE  
SIDE CAUSED DISTORTION  
OF THE MAST

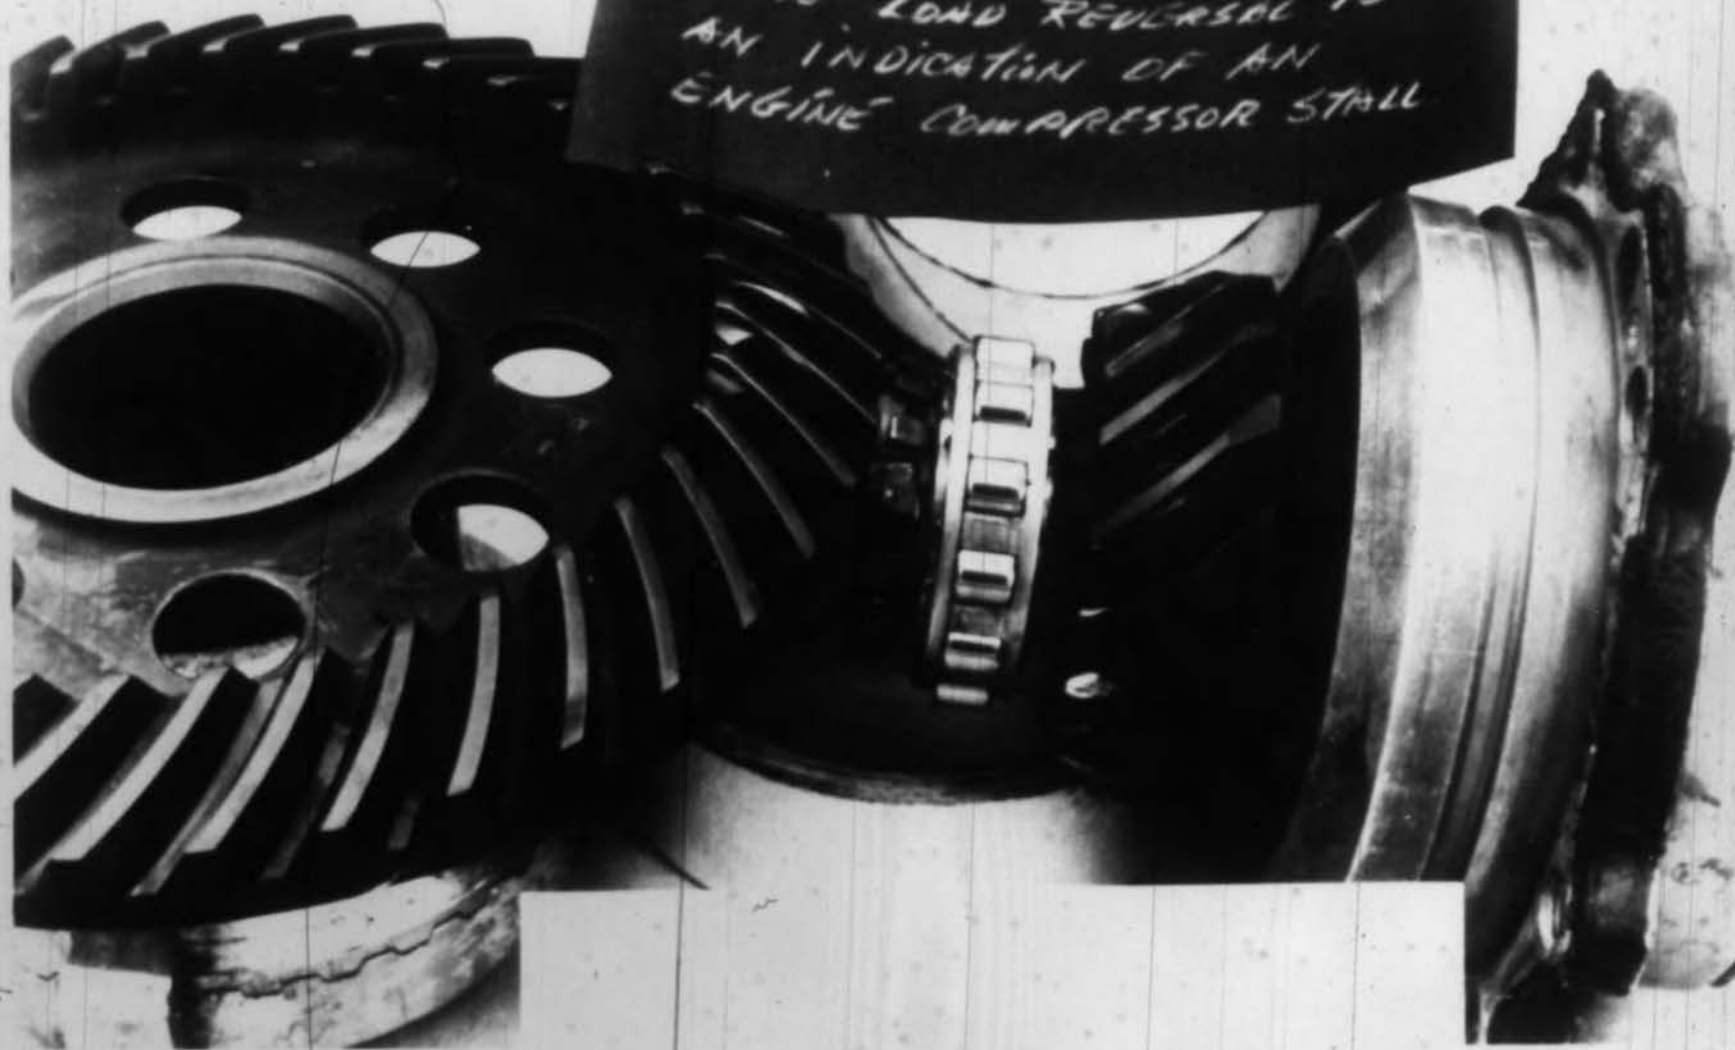
UN-18 A/C BU NO 152437  
NO EVIDENCE OF REVERSE  
LOADING NOTED ON THE  
CONST SIDE OF THE GEARS  
FROM THE 90° GEAR BOX  
NOTE LOAD REVERSAL IS  
AN INDICATION OF AN  
ENGINE COMPRESSOR STALL

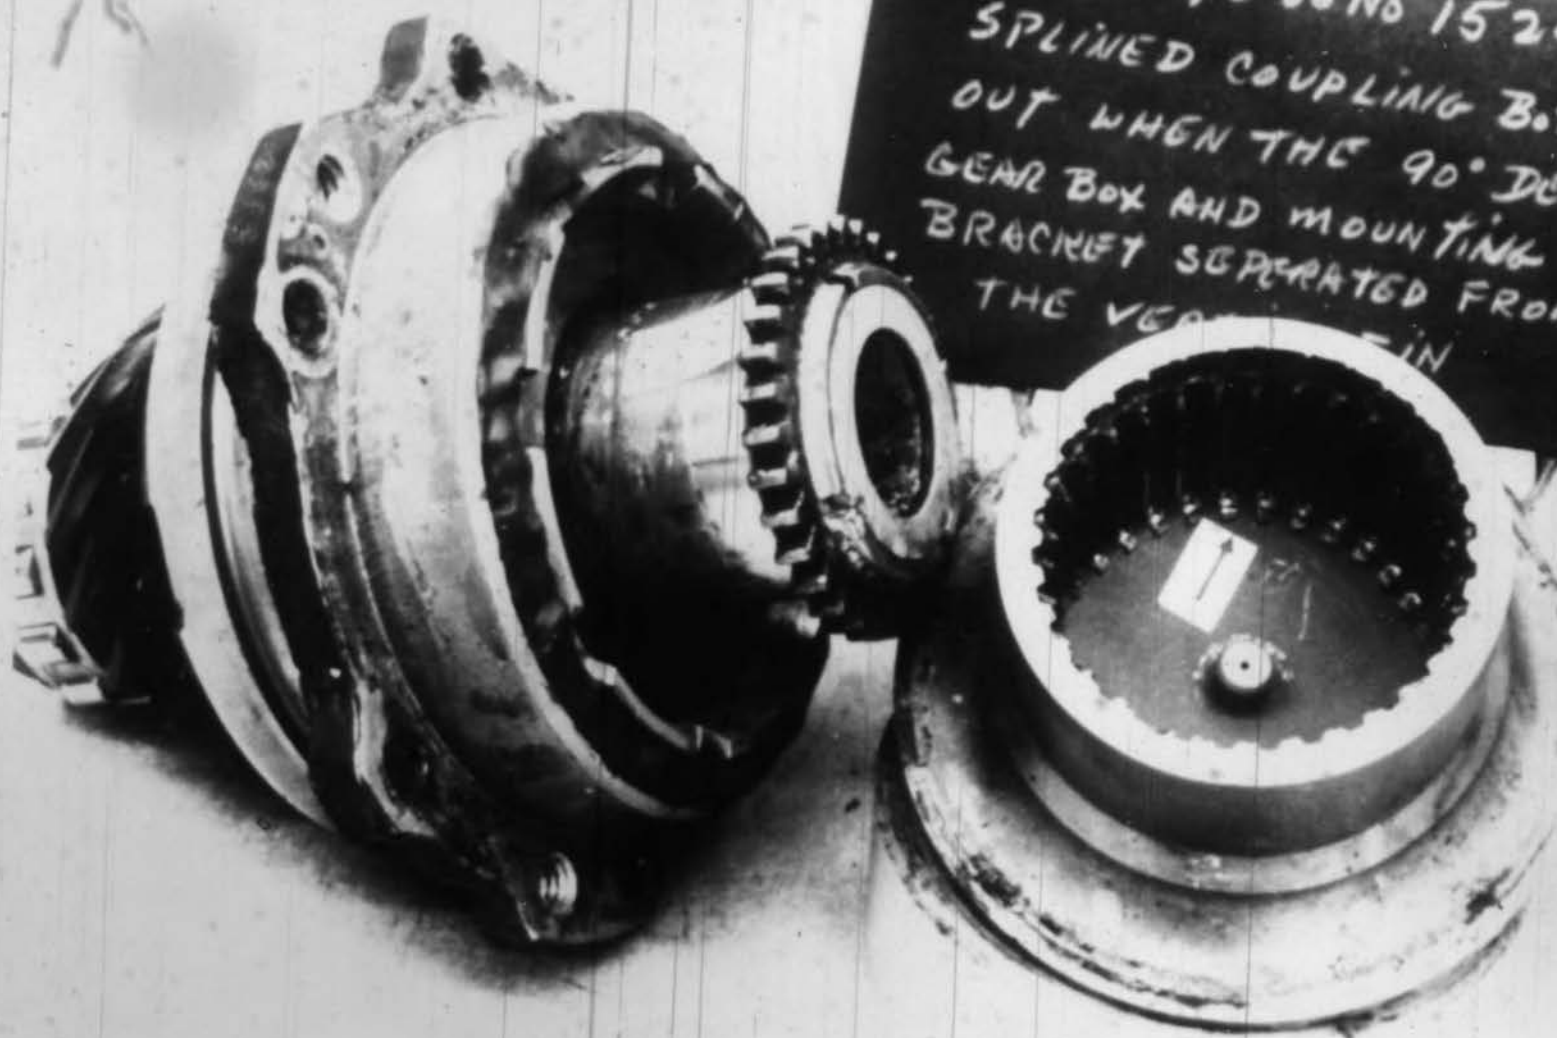
UH-1E A/C BU No 152437  
SPLINED COUPLING BOTTOMED  
OUT WHEN THE 90° DEGREE  
GEAR BOX AND MOUNTING  
BRACKET SEPARATED FROM  
THE VER... IN

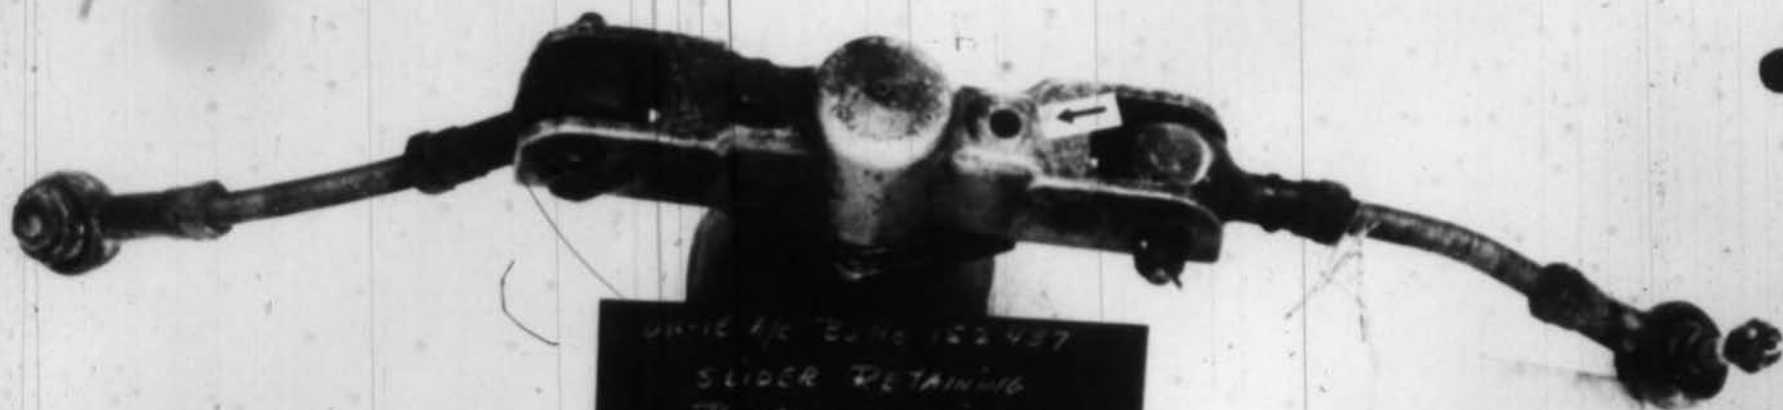
(3) One bolt, P/N AN174-15A, and self-locking nut, P/N NAS679-A4, was missing from the crosshead assembly, P/N 204-011-711-1. The physical evidence showed that the nut had backed off and the bolt came out prior to impact.

3. CONCLUSION. The most probable cause of this accident is the improper securing of a self-locking nut in the tail rotor control system. The possible causes for the nut to back off would be improper torquing procedure or loss of locking feature due to re-use of a self-locking nut in a critical area.

UH-1E BuNo 152437  
SLIDER RETAINING  
BOLT WAS MISSING  
FROM CROSS HEAD ASSY  
ON TAIL ROTOR CONTROL

b. The NAVAIRSAFECEN has initiated action to replace the self-locking nut with a self-locking castellated nut and a cotter pin.

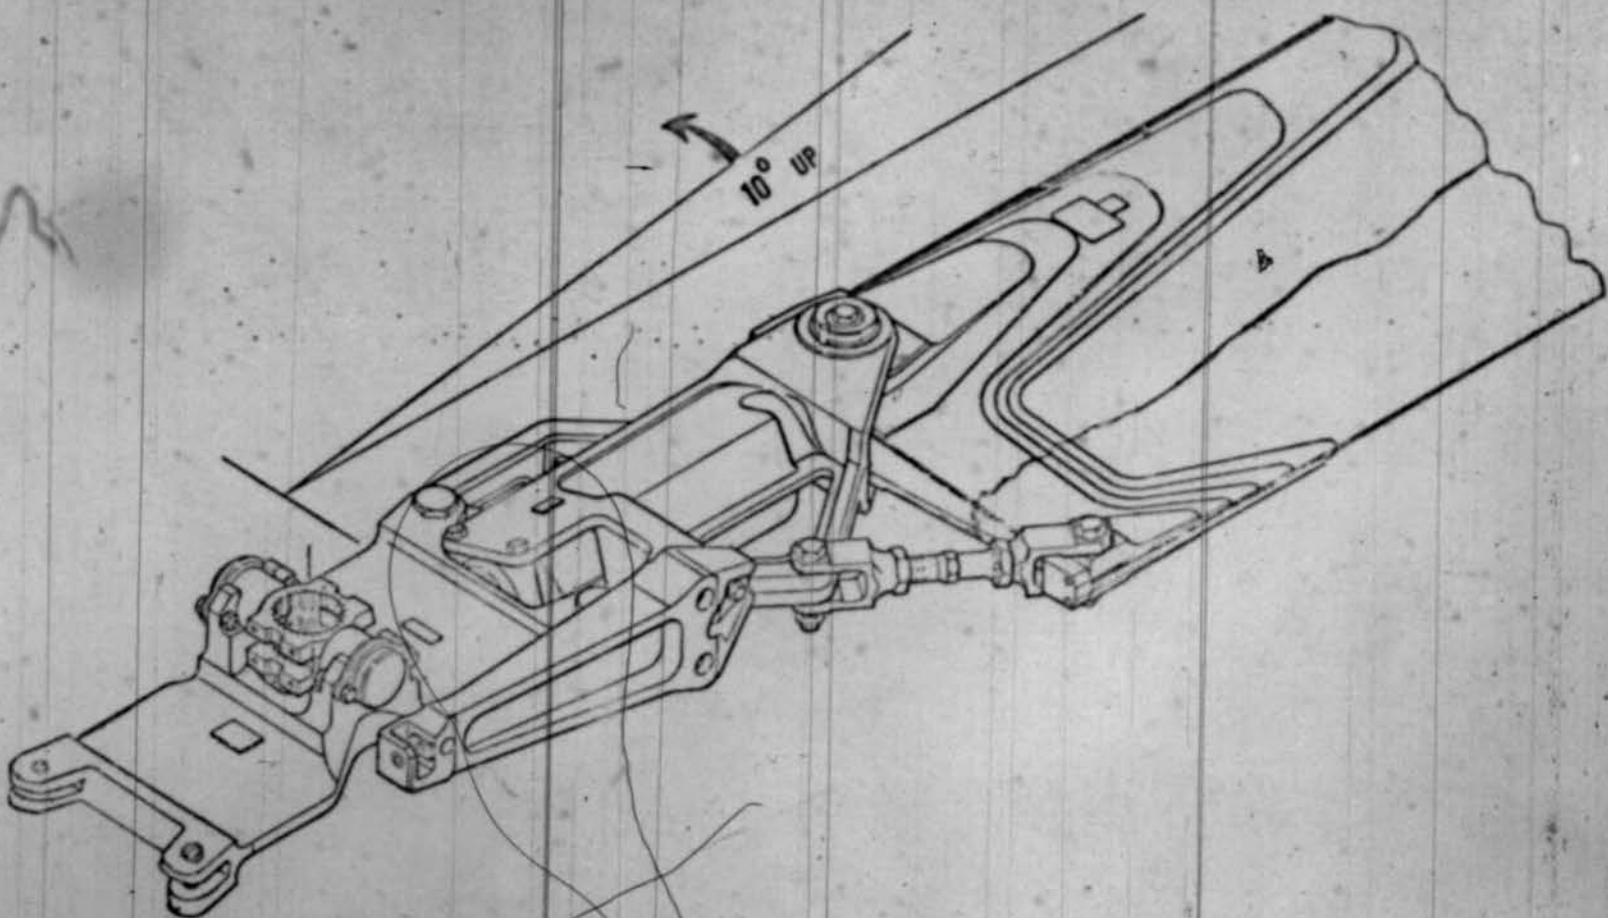
FIG. 1

LOCATION OF FRACTURE IN THE WHITE MAIN ROTOR BLADE  
AND THE BEND IN THE YOKE
